National Civil Rights Museum

Facility Assessment Report

SBC Project No. 529/000-16-1998

August 19, 2020

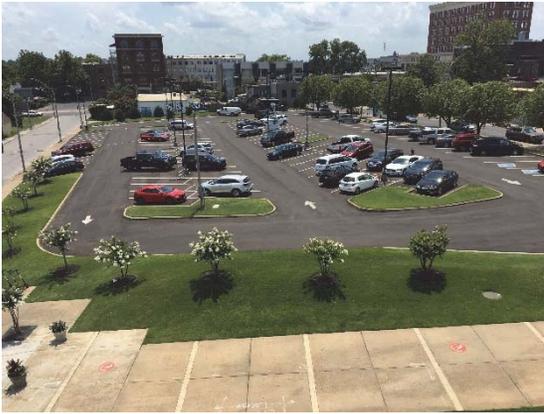
Visitor parking lot overlay

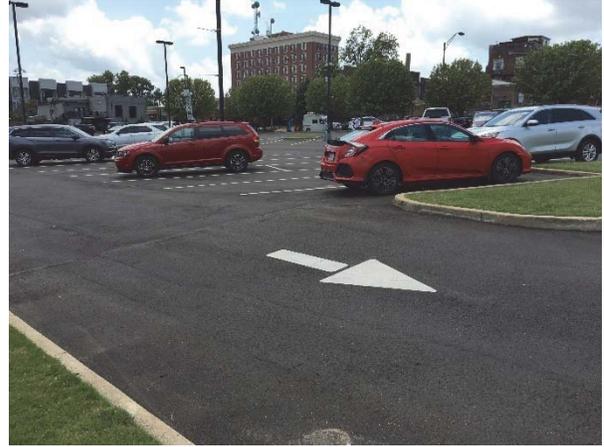
New asphalt and striping

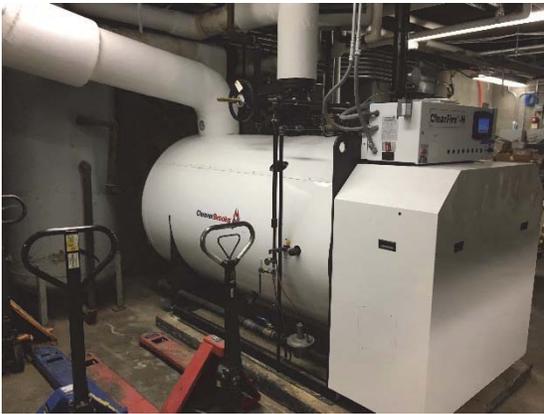
Boiler replaced

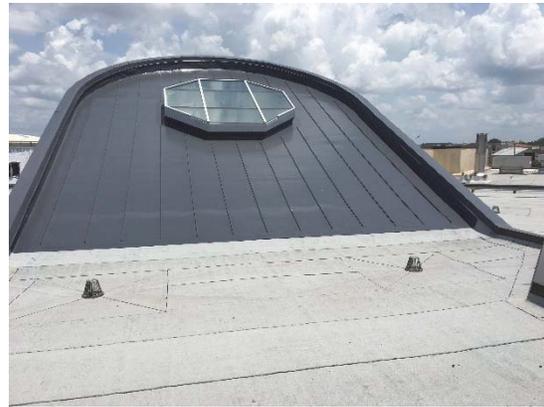
Skylight and roof replaced

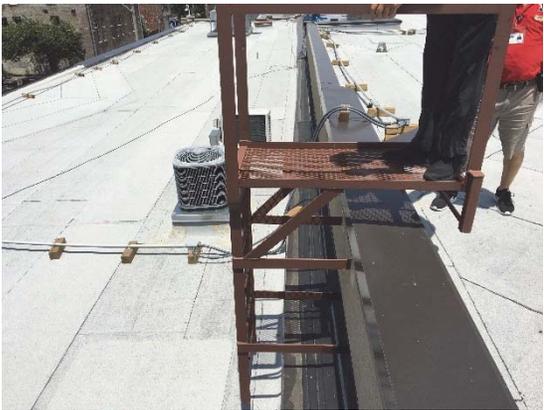
New roof and access ladder

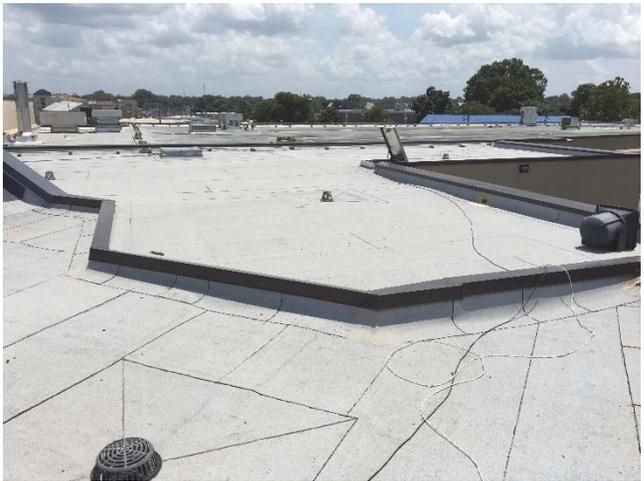
Roof replacement work completed

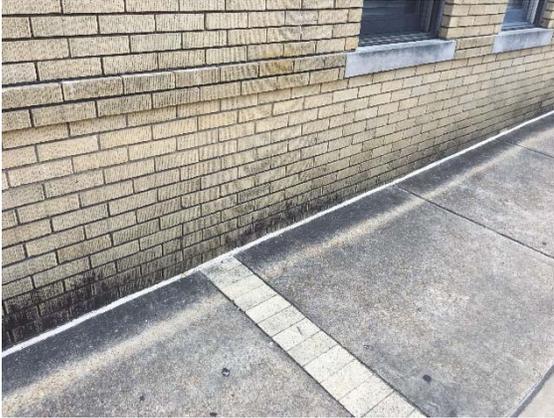
Completed caulking at base of wall

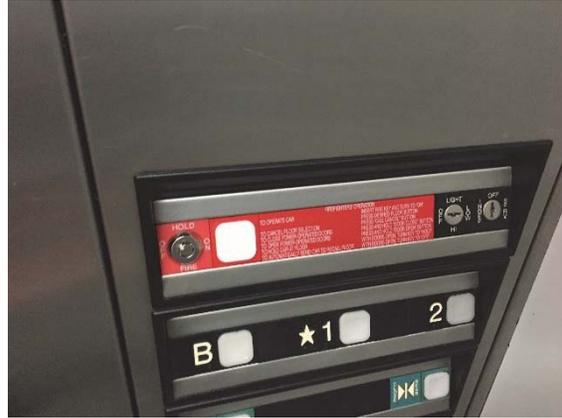
Upgraded elevator controls

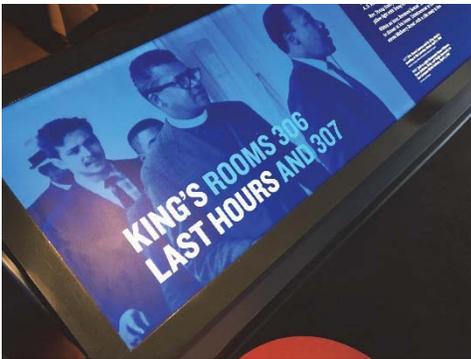
Refinished exhibit frames

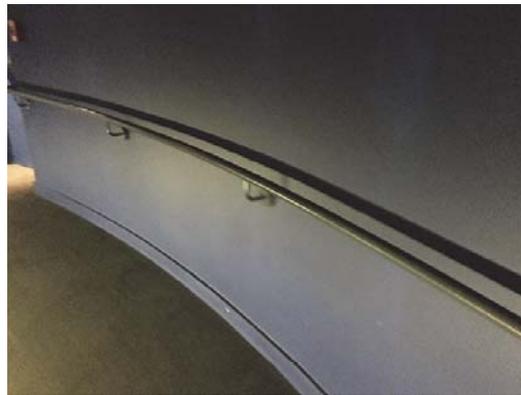
Refinished handrails

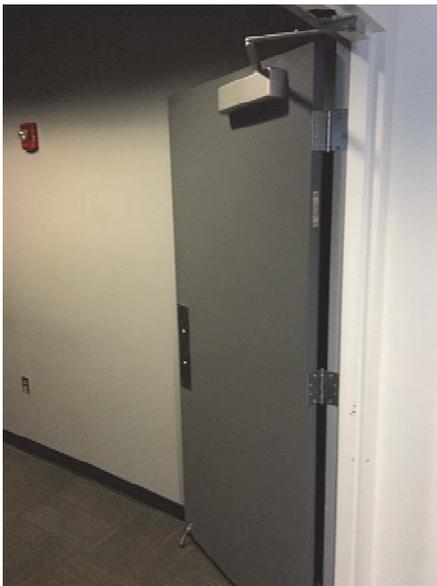
New double doors at service elevator

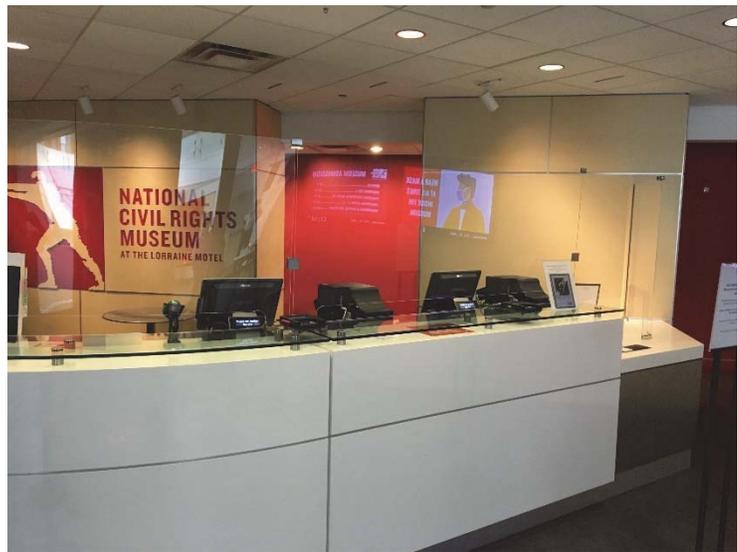
Plexiglass dividers added to the reception desk

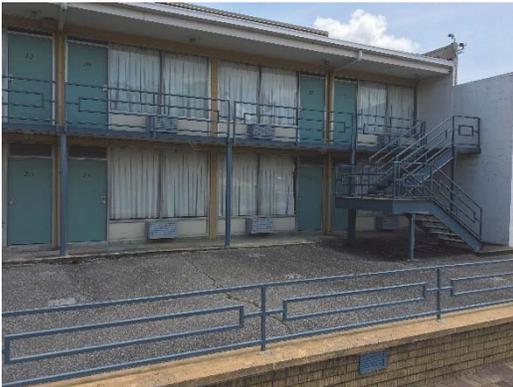
Metals to be refurbished and repainted

Exterior caulk joints have been replaced and are in excellent condition. The painted metal railings, stair risers, and stringers on the front exterior of the motel have continued to corrode. Rust should be removed, treated, and repainted. Downspouts at the motel should be extended through the concrete walks and out to the pavement.

- Refinishing and repainting of metals at the front motel courtyard
- Replace lights in knee wall at exterior plaza
- Refurbish rear corner building sign
- Consider adding graphics or signage to the Martin St. façade for better identification for visitors

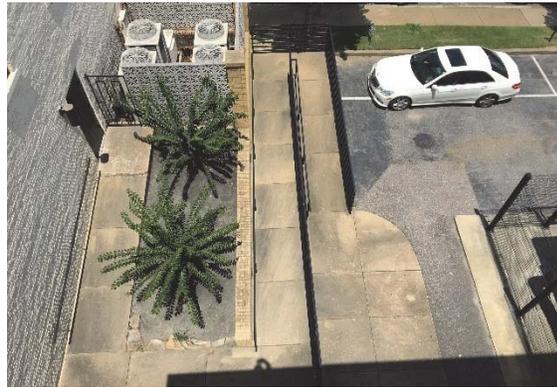
The rear employee ramp should be evaluated to determine if it needs to be revised to meet ADA standards.

Rear ramp to be evaluated for updates

- Evaluate employee entrance ramp for repairs/ ADA upgrades
- Parking lot lighting upgrades
- Upgrade trash enclosure; adding a perimeter fence with gate at the service area

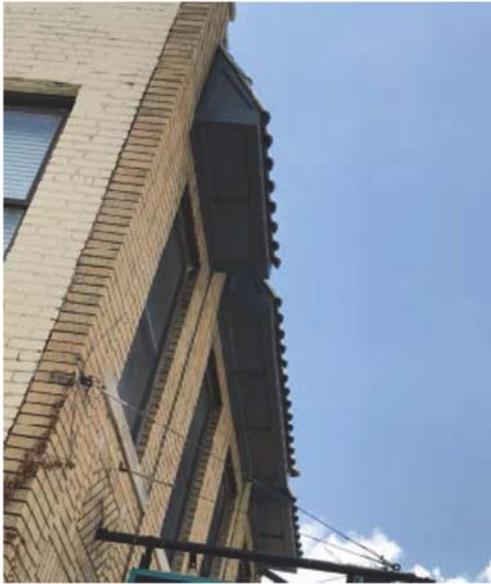
With the recently completed roof replacement project, the roof, skylight, and copings are in very good condition. The tile roof overhangs above the windows have also been completely refurbished with deteriorated wood replaced, new paint, and new roof tiles.

Overhangs fully refurbished

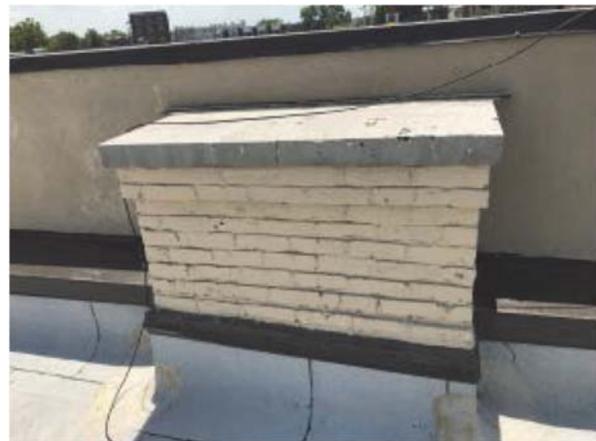
Back of parapet wall tuckpointed and sealed

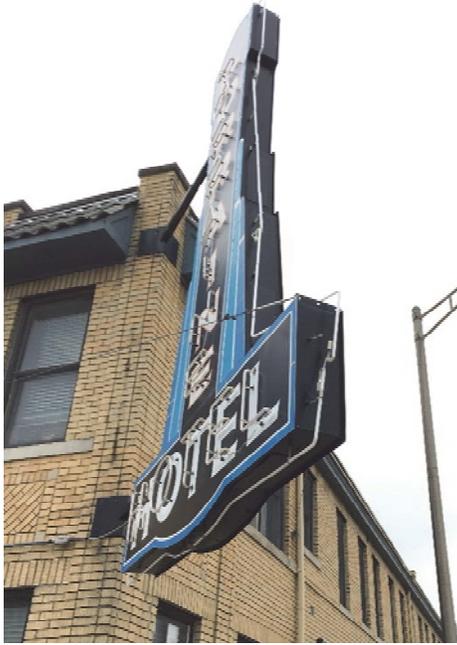
Small areas of masonry need tuckpointing and portions of the brick will need cleaning. The vertical "Lorraine Hotel" blade sign at the corner of the hotel needs to be refurbished with new vinyl.

Corner sign cracked vinyl

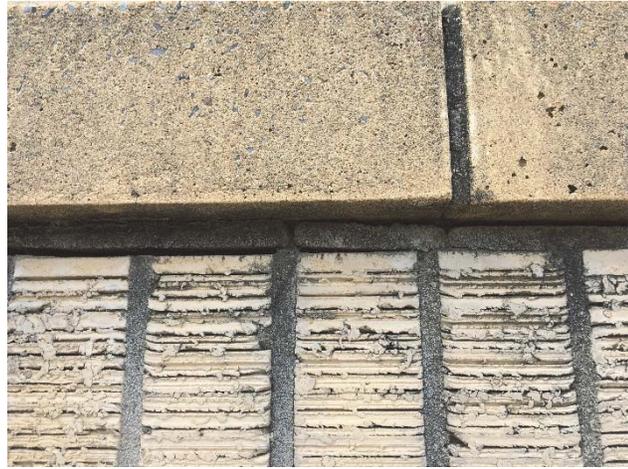
Tuckpointing needed at masonry sill

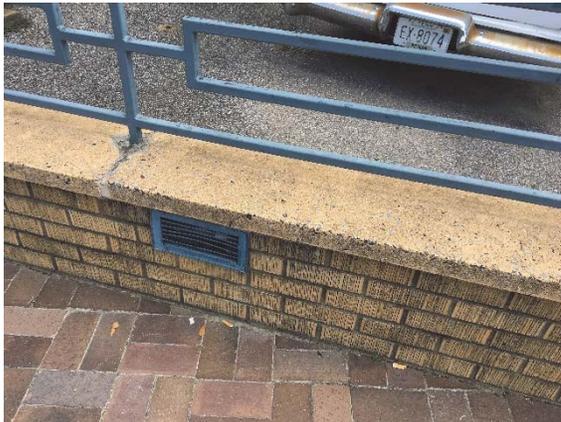
Lights recessed into the masonry knee wall at the plaza are not functional and will need to be replaced.

Recessed lighting needing repairs

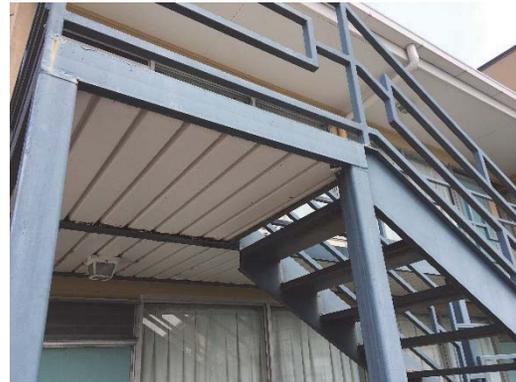
Rust forming under stairs

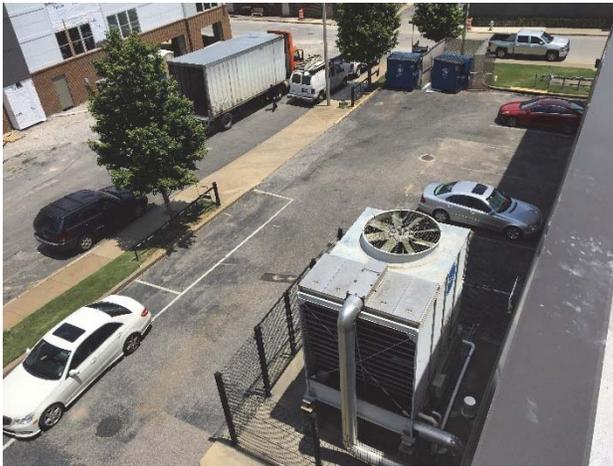
The dumpster enclosure fence will need to be replaced and expanded to enclose both dumpsters. It is currently not sized properly based on use. Consider fencing in the entire service area to prevent unauthorized vehicles from parking in this location. If a fence is added, an automatic gate may be needed for access to the parking spaces, deliveries, and trash removal.

Trash enclosure undersized

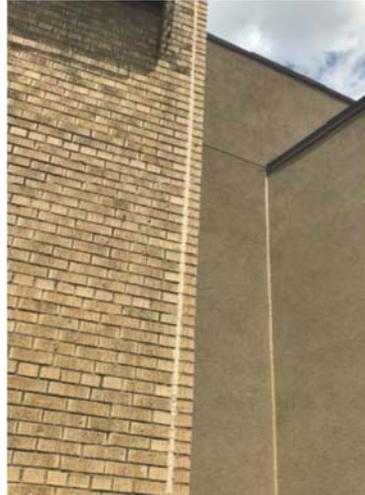
Expansion joints caulked

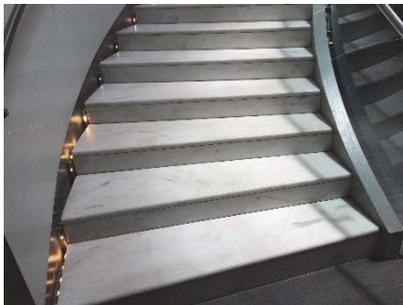
The interior stair in the lobby under the skylight will need to have a non-slip surface installed on the stone treads. A permanent solution such as routing of the edge of the treads is recommended and will need to be approved by the fire marshal prior to the work being performed.

Lobby stair stone treads

- Additional interior security measures and access control systems
- Install non-slip material at the lobby stair
- Existing building commissioning
- Building Automation System for the HVAC system

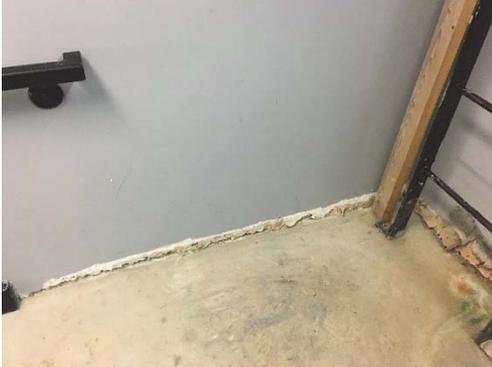
Interior stairs and ramps appear to be in good shape. An area of the stairwell below the roof hatch has some water damage and needs to have the drywall replaced and new wall base added. The interior stairwell handrails have some areas of paint worn off.

Damage/ missing base below roof ladder

- Lobby could use a fresh coat of paint
- Window trim repairs and refinishing
- Replace stained tile in conference area
- Replace damaged drywall and install base at portion of stairwell

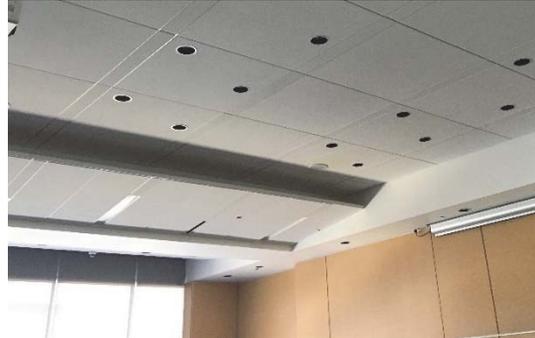
A water-stained ceiling tile in the large upstairs meeting space needs to be replaced.

Stained ceiling tile

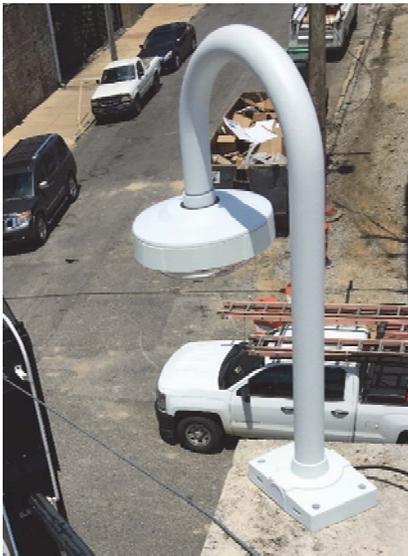
Security monitoring system has been upgraded with additional cameras added on the exterior. The museum now has additional views of the exterior perimeter of the building. A monitor displaying a camera view of the dock from inside the receiving area has been added. Additional security measures, including access control upgrades, should be evaluated for the interior of the museum.

New security camera installed
